Dealer Service Information Service Bulletin No. 94-014

M3 Option Card FPGA Upgrade

DATE: 11/2/94
MODEL: Micro Lynx M3 Option Card
REVISION: A6
SERIAL NO: **Option Card Serial Number 465 through 545**
SOFTWARE: All
REQUIRED TOOLS:

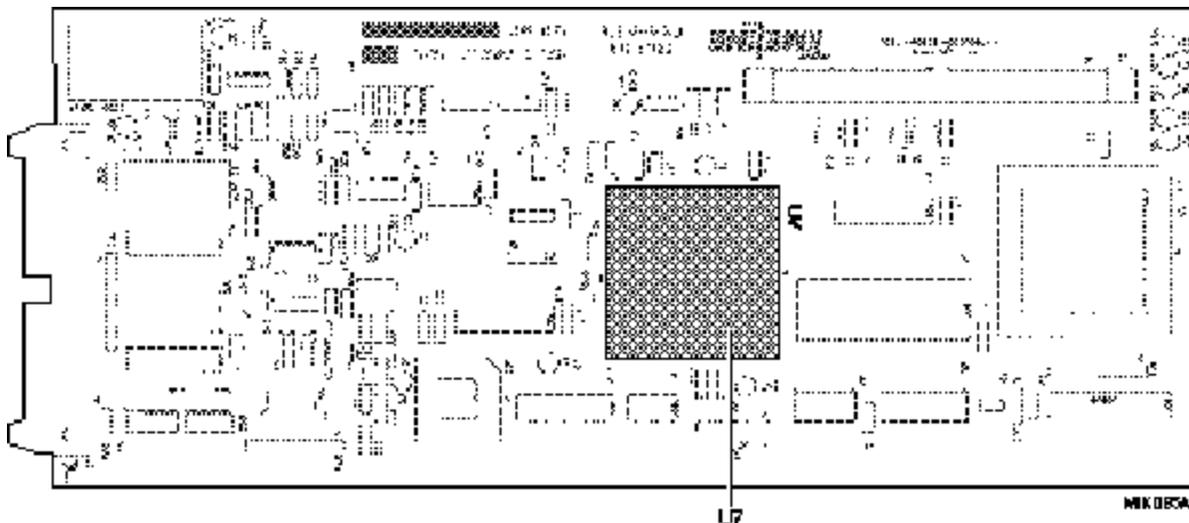
Figure 3. FPGA IC Location

5. On the M3 Option Card locate U7. (See Figure 3) If the letters “ATT” appear on the IC, contact TimeLine for an RMA number. If the Xilinx logo (X) appears on this IC, no replacement is necessary.

If the FPGA IC in U7 is a Xilinx IC, the failure is unrelated to this Service Bulletin, and must be diagnosed further.
