Service Bulletin No. 95-001

M3 Option Card PCB Modification

MODEL: Micro Lynx M3 Option Card

SERIAL NO: All M3 Option Cards prior to Serial Number 430

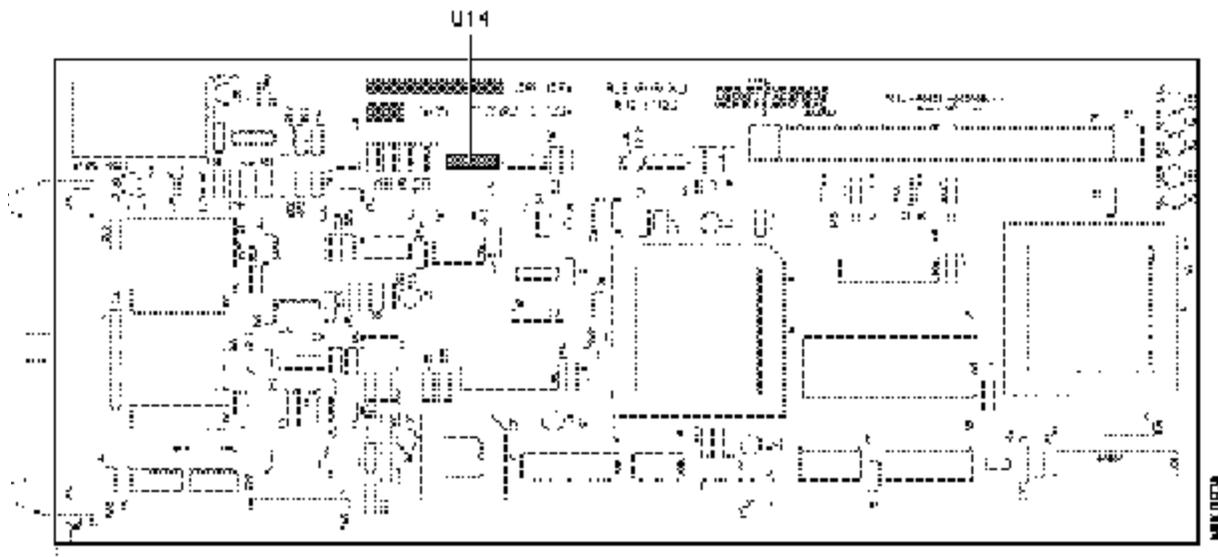
Figure 3. Component Location

In some Micro Lynx M3 Cards, the M3 Bandwidth Select analog switch works intermittently. This is due to the IC at U14 being operated out of its recommended voltage supply range, depending on the manufacturer of the part.

5. On the M3 Option Card locate U14. (See Figure 3) If the IC is made by National, SGS Thompson, Phillips or Signetics, contact TimeLine for an RMA number. This component will need to be replaced.
