### Micro Lynx SU Board Modification

DATE: 1/30/95

MODEL: Micro Lynx System Unit

SERIAL NO: All System Units with Serial Numbers 951 through 1022

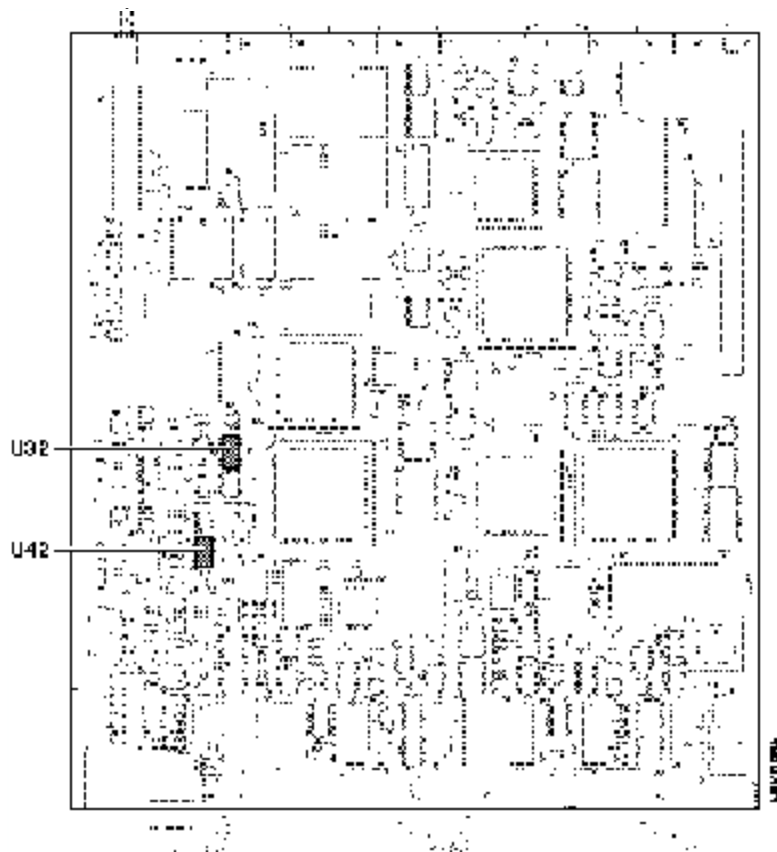
**Figure 2. Component Location**

In some Micro Lynx System Units, the AUX REF OUT Signal and the Bandwidth Selection function works intermittently. This is due to IC's at U32 and U42 being operated out of their recommended voltage supply range, depending on the manufacturer of the part.

4. On the SU Board, locate U32 and U42. (See Figure 2) If the IC were made by National, SGS Thompson, Phillips or Signetics, contact TimeLine for an RMA number. These components will need to be replaced.
